## CommScope Smooth-Wall Transmission Line System Survives Extreme Testing Without Secondary Waterproofing

**Extremeflex™ Aluminum**

Coaxial Cable:  
Dissimilar Metals Engineering Analysis

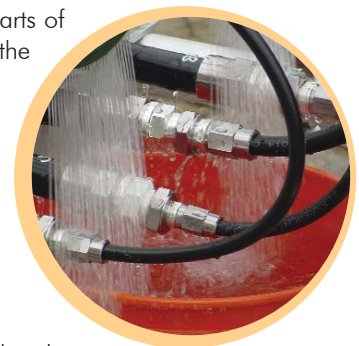
The test team conducted pre-test benchmarking as before. The samples were then placed in the test chamber where multiple showerheads were situated a few inches away from the assemblies and aimed directly on the cable-connector junction. Water spray from the showerheads exposed the cable-connector assemblies to the equivalent of 27 inches of rain.

The samples were then immediately subjected to thermal cycling during which temperatures ranged from -20°C (-4°F) to 27°C (80.6°F). When the temperature dropped to the freezing point, the samples were sprayed with a cold-water mist to build an ice layer. As the ice melted, the water had the opportunity to migrate into any gaps between the cable-connector interface that may have developed. Each cycle lasted 6 hours. The test concluded at the end of 8 cycles; at which time, the assemblies underwent post-test electrical analysis.

Of the 32 individual cable-connector assemblies in the eight test samples, not a single connection failed.

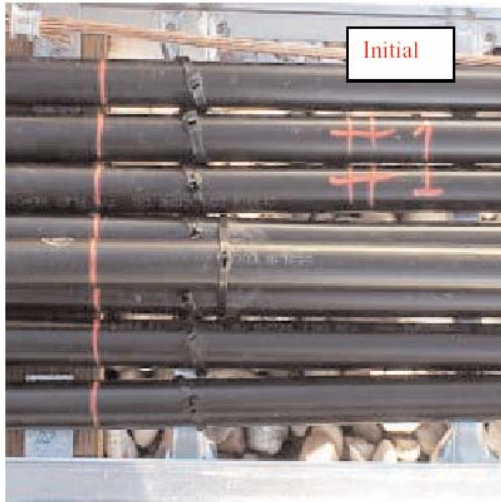
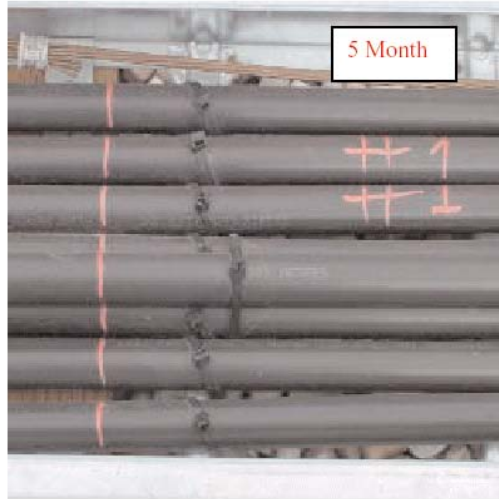
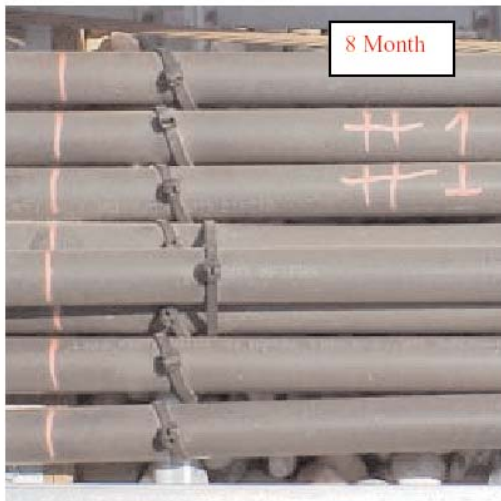
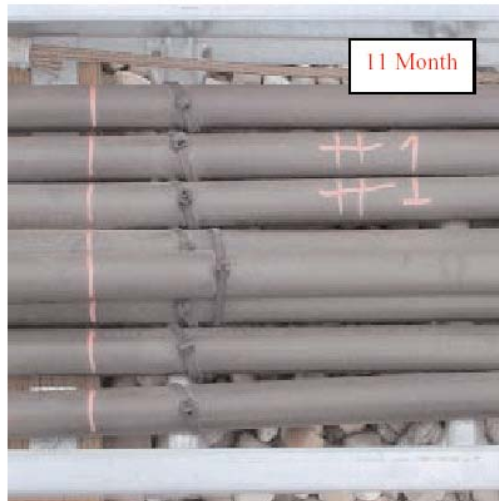
Cable Markings #1

During each visit engineers documented the cable assembly's electrical performance and photographed it in order to compare it to previous findings. To date no change in performance, dimensional measurements, or photographic evidence has been detected.

These pictures show the aluminum cable fastened to the steel trays at various chronological times over a one-year period.

When the site was erected, engineers recorded baseline measurements for the cable/connector system to be compared with subsequent findings. Engineers also photographed the installation providing a visual comparison of the effect of thermal contraction and expansion. Since then, they have returned at one-, five-, eight-, and eleven-month intervals with additional visits planned at 18 and 24 months. (See site photos on following page)
